TECHNICAL REPORT S-77-1

INVESTIGATION OF CONSTRUCTION TECHNIQUES FOR TACTICAL BRIDGE APPROACH ROADS ACROSS SOFT GROUND

February 1977

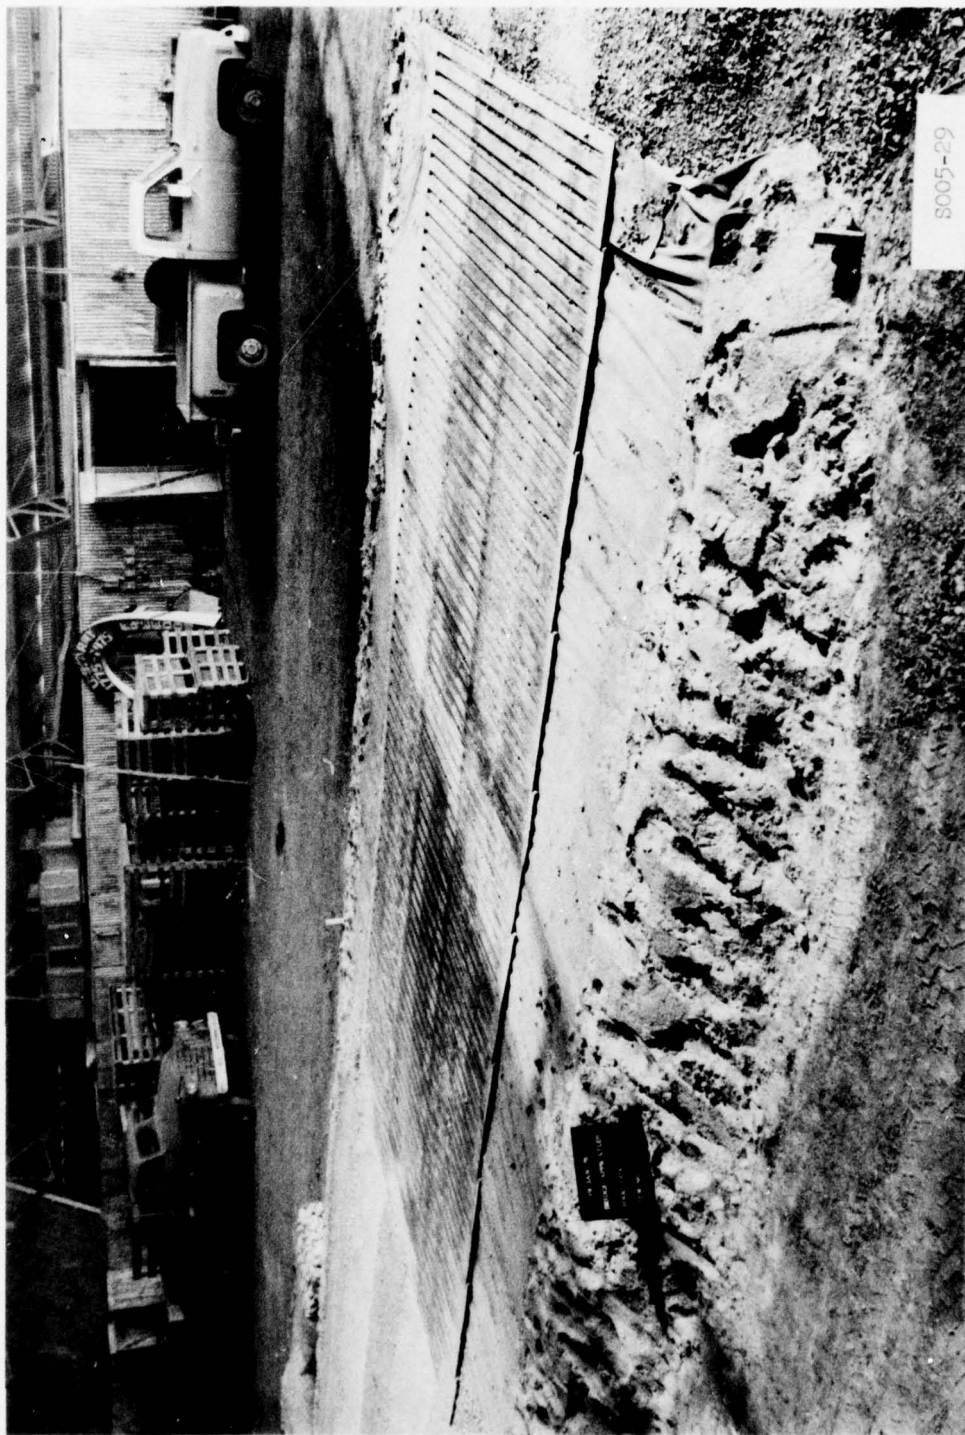
32. During the first 500 coverages of test traffic, the M8A1 mat item with runners tended to seat itself into the soft subgrade. Plate 3 shows a typical cross section showing the elevation of the mat surface before traffic and after seating at 500 coverages. Photo 15 shows the mat in excellent condition after 1000 coverages. The mat was very stable during traffic and did not shift or require any anchoring. After 15,000 coverages, the mat was still in excellent condition and showed no signs of damage.

Photo 15. Item 1 after 1000 coverages

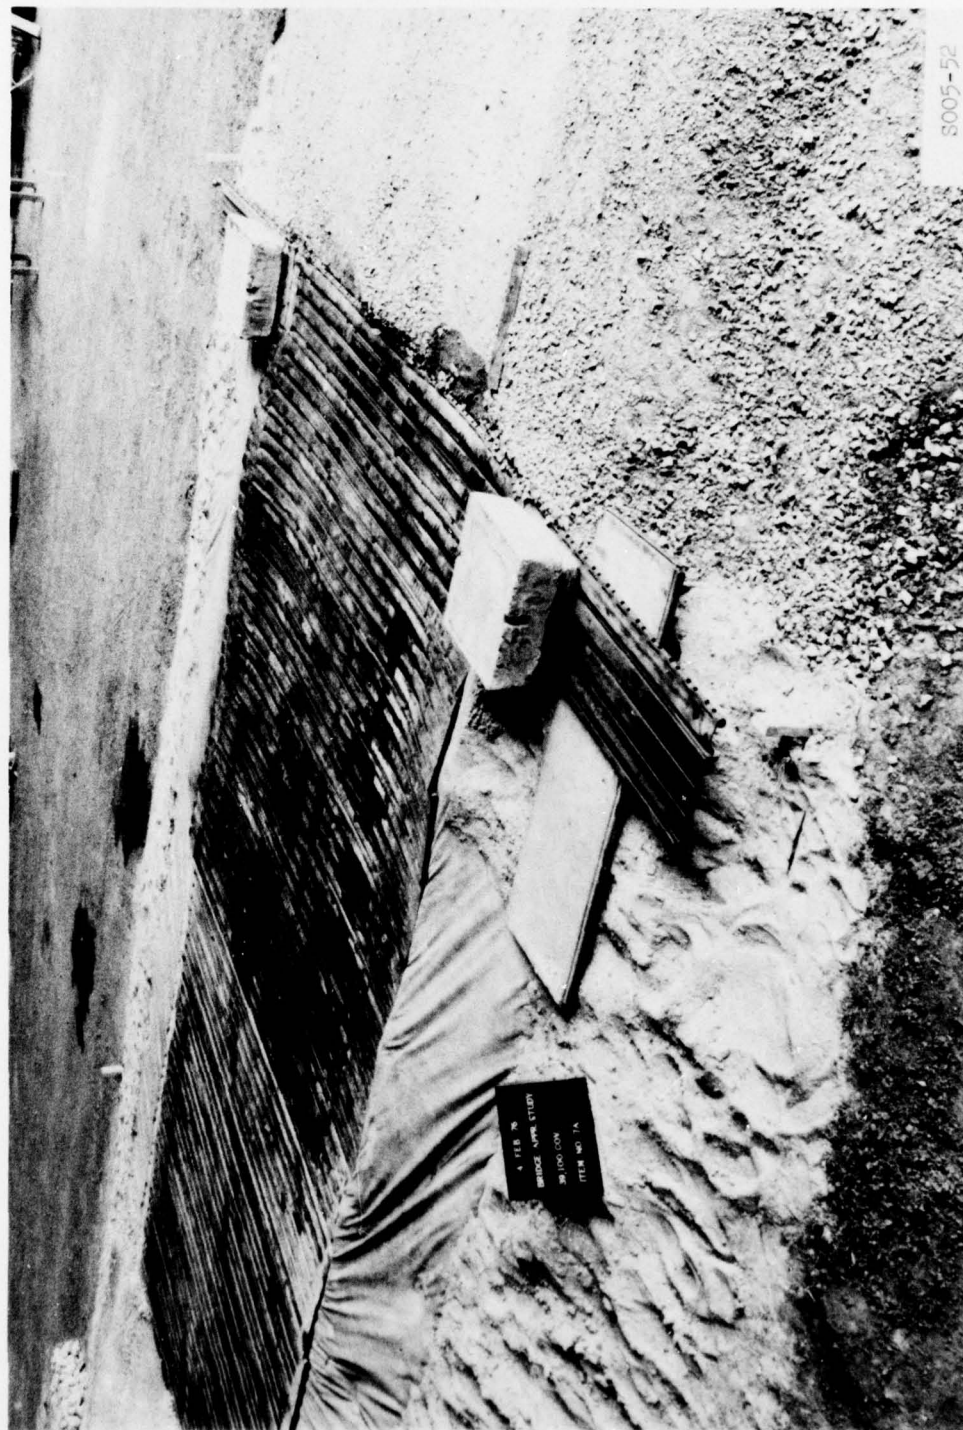
33. Since it appeared that the mat would handle a large amount of additional traffic without damage, the mat runners were removed from half the item to compare the item performance with and without the runners. The portion of item 1 without runners was designated item 1A. Since initial traffic on item 1A caused substantial movement in both the mat and subgrade, lead weights were used to anchor the end of the mat on item 1A. After 39,100 coverages (Photo 16), item 1A was considered failed. One mat panel was broken and many of the bayonet side connectors had broken off. Plate 3 shows a typical cross section of the mat surface at zero and at 39,100 coverages. Approximately 2 to 3.5 in. of subgrade soil had been displaced under each wheel path.

Photo 16. Item 1A after 39,100 coverages

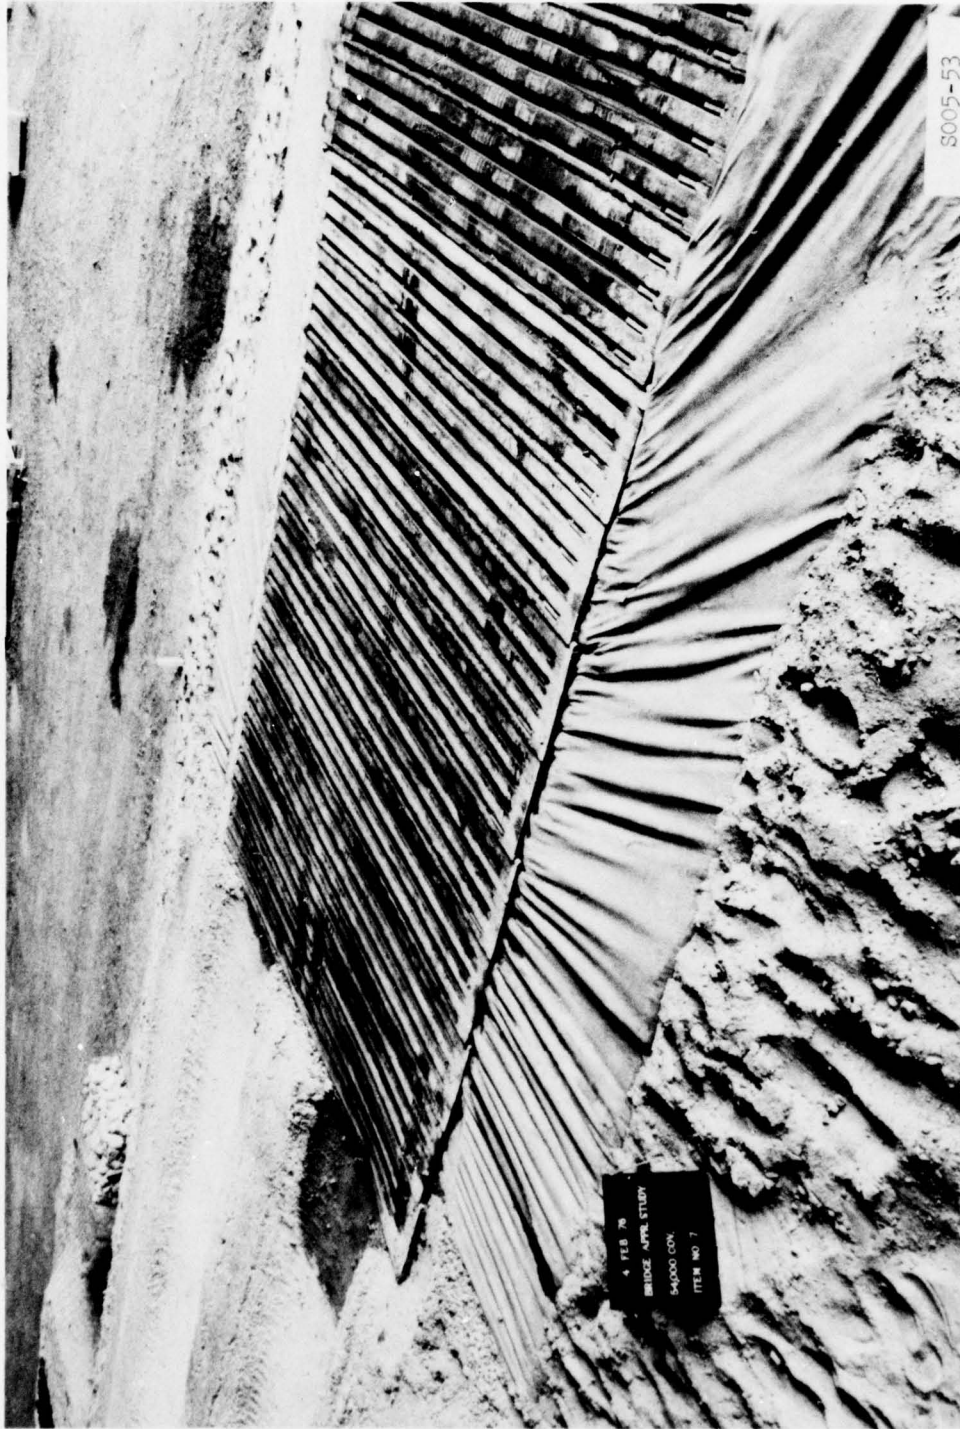
34. The remaining portion of item 1 remained in excellent condition at the conclusion of traffic after 54,000 coverages (Photo 17 and Plate 3).

Photo 17. Item 1 after 54,000 coverages

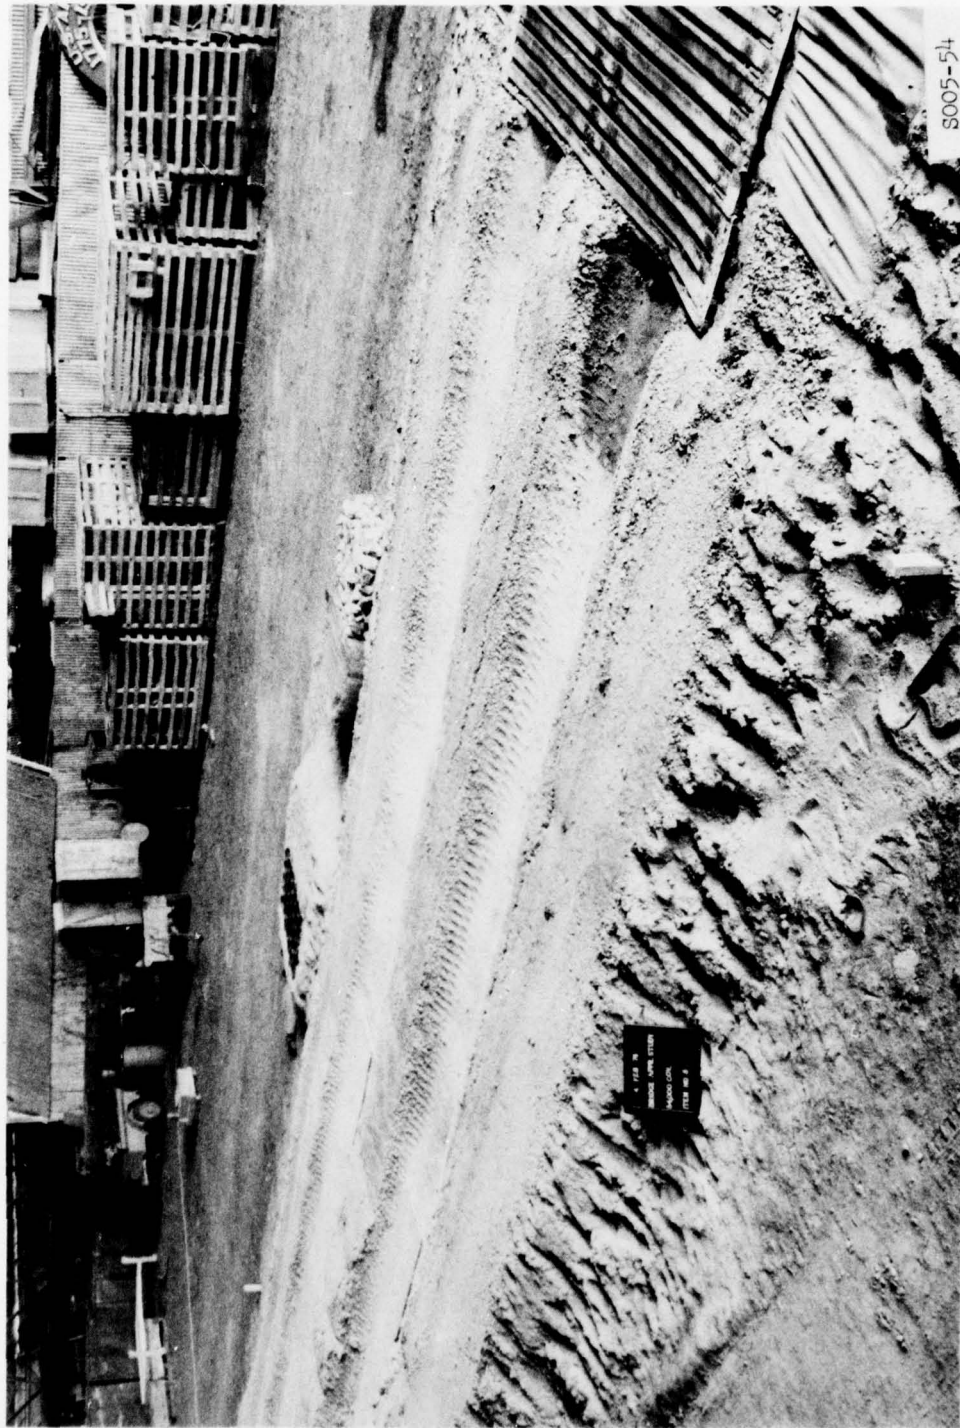
36. A cross-section excavation of the item showed that no gabion wires were broken. The surface wearing course had filled the surface voids in the gabions to a depth of approximately 2 in. The subgrade material had entered from the bottom of the gabions and filled all remaining voids within the gabions.

Photo 20. Item 2 after 54,000 coverages

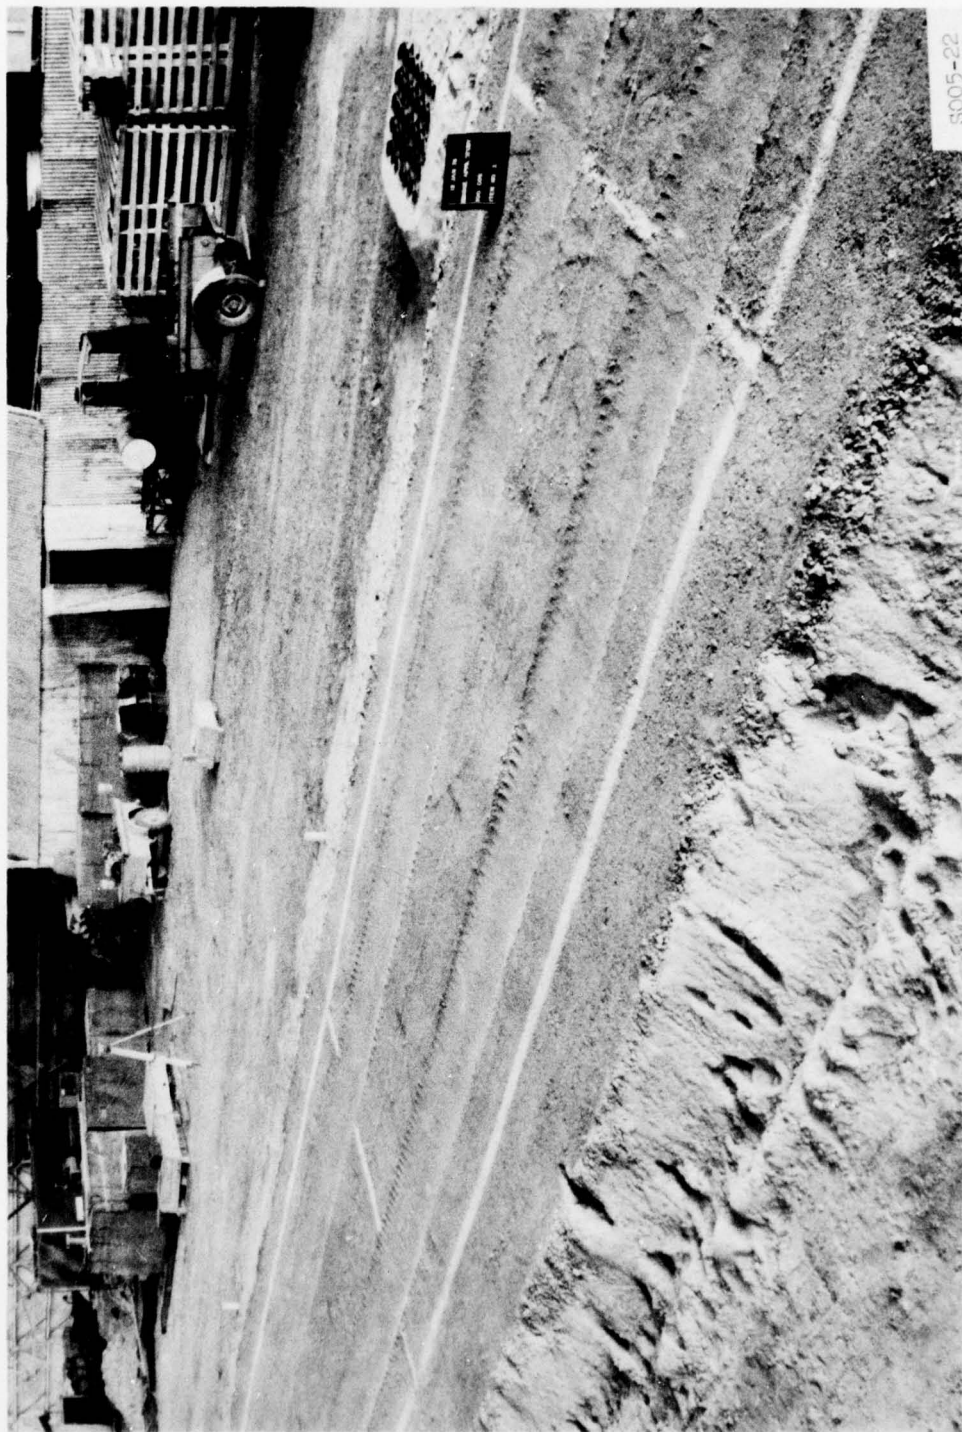
37. Performance of this large-compartment sand-confinement item was surprisingly good. A total of 11,500 coverages were applied before an 11-in. rut developed in the west wheel path. At 100 coverages (Photo 21) the item was in excellent condition and had an average rut of 2.2 in. At 5500 coverages (Photo 22), the average rut was 7.3 in. and signs of upheaval and shifting of sand within the compartments could be seen. Photo 23 shows the item after 11,500 coverages when 11 in. of rutting had finally developed in the west (foreground) wheel path. Typical cross-section data for this item are shown in Plate 5. The gabion wire and the polyester fabric were still in excellent condition at the conclusion of traffic.

Photo 21. Item 3 after 100 coverages

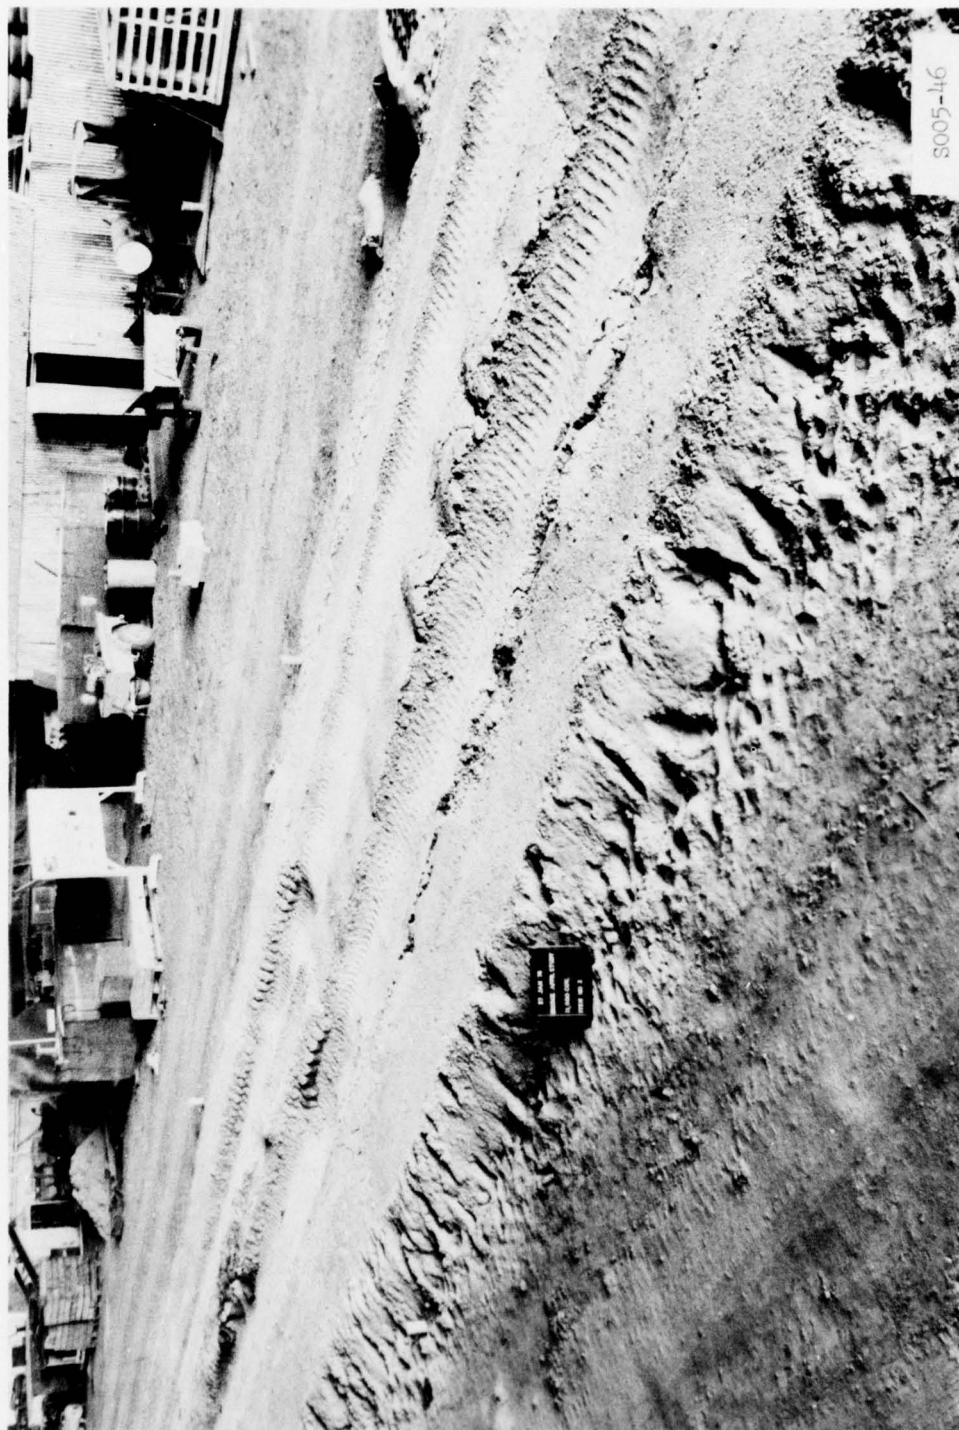
Photo 23. Item 3 after 11,500 coverages

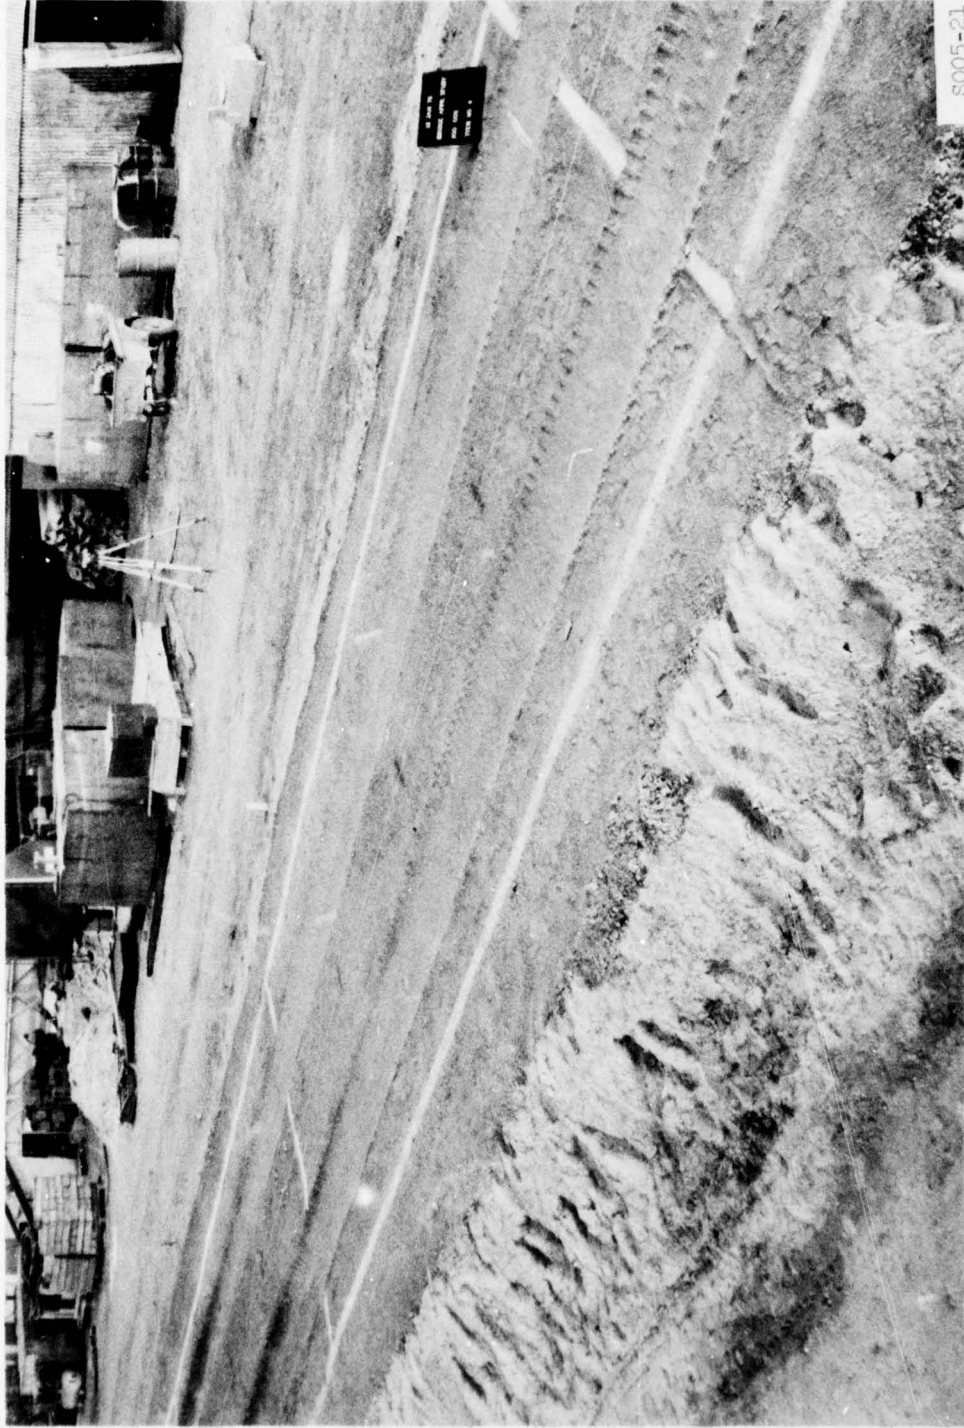
38. This small-compartment sand-confinement item performed extremely well during the first 500 coverages. After 100 coverages (Photo 24), the average rut depth was 1.5 in. Visual observation showed this item to be very stable during the first 500 coverages. However, after 500 coverages, the tandem-axle load was increased from 25,000 to 35,000 lb, and the item performed significantly different with the new traffic load. Additional traffic caused a spot type failure to start to develop in the west wheel path. Photo 25 shows the item after 1000 coverages when the potential failure was noticed. Photo 26 shows the item after 2500 coverages when the average rut depth was slightly over 6 in. At this coverage level, the plastic tubing became visible as the spot failure continued to develop. After 5500 coverages (Photo 27), an 11-in. rut had developed at one spot, and the differential of the truck began to lift the plastic tubes from the item. It should be noted in Photo 27 that although half the item had developed an 11-in. rut, the remaining portion had an average rut of

Photo 24. Item 4 after 100 coverages

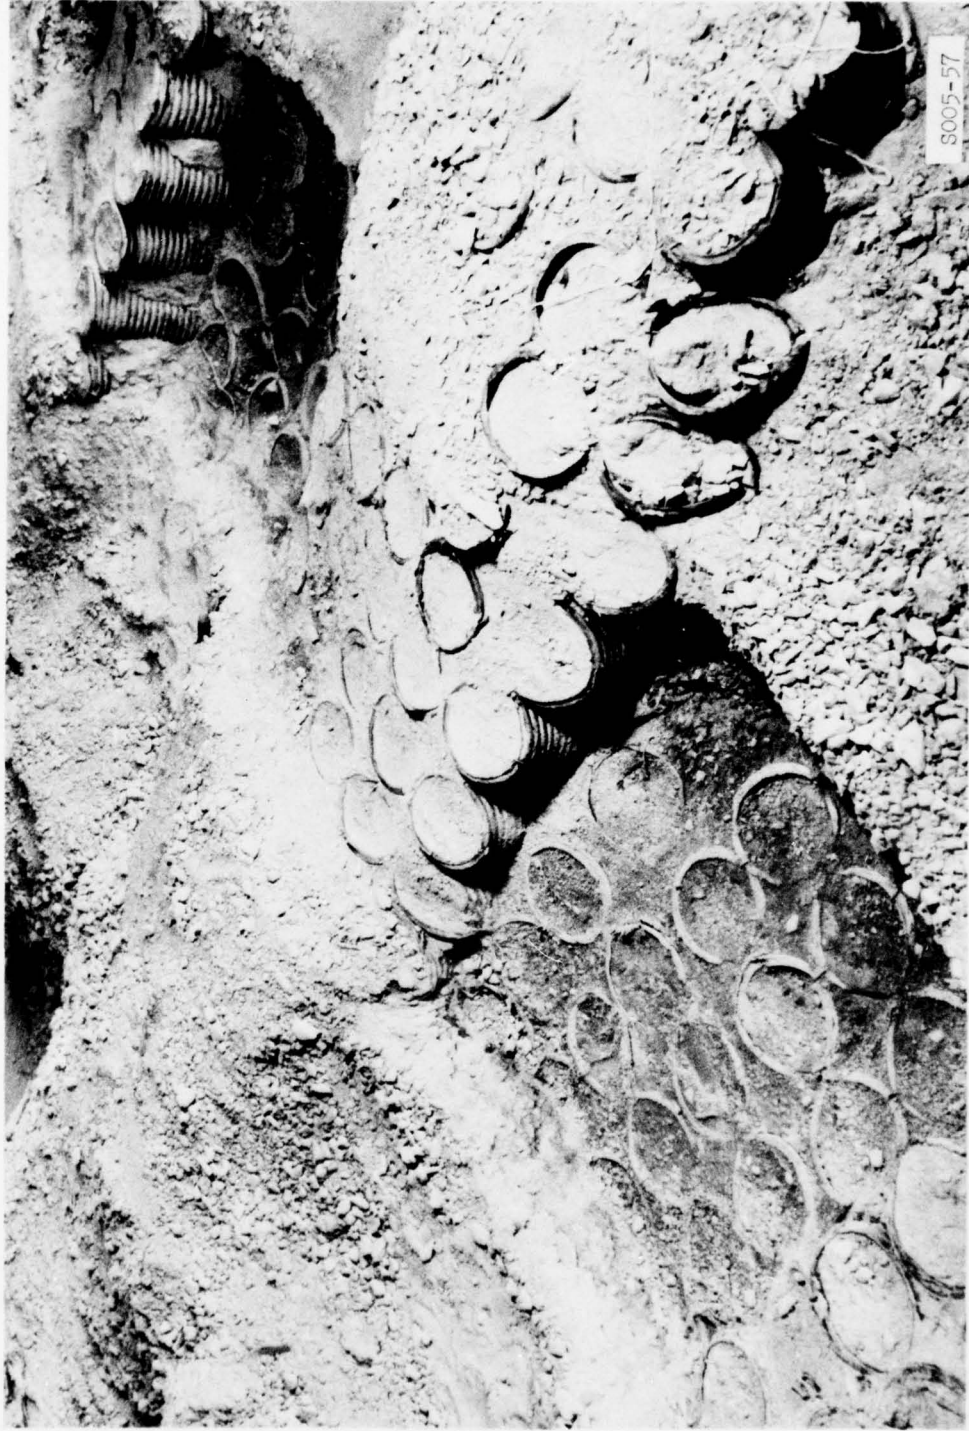
only approximately 6 in. Typical cross-section data are shown in Plate 6. Photo 28 shows a typical cross-section view after the wearing surface was removed after 5500 coverages. The individual sand-filled plastic tubes along each wheel path had been pushed into the subgrade. This caused the subgrade to upheave between the wheel paths and along the outer edge of each wheel path.

Photo 28. Item 4 with wearing surface removed after 5500 coverages

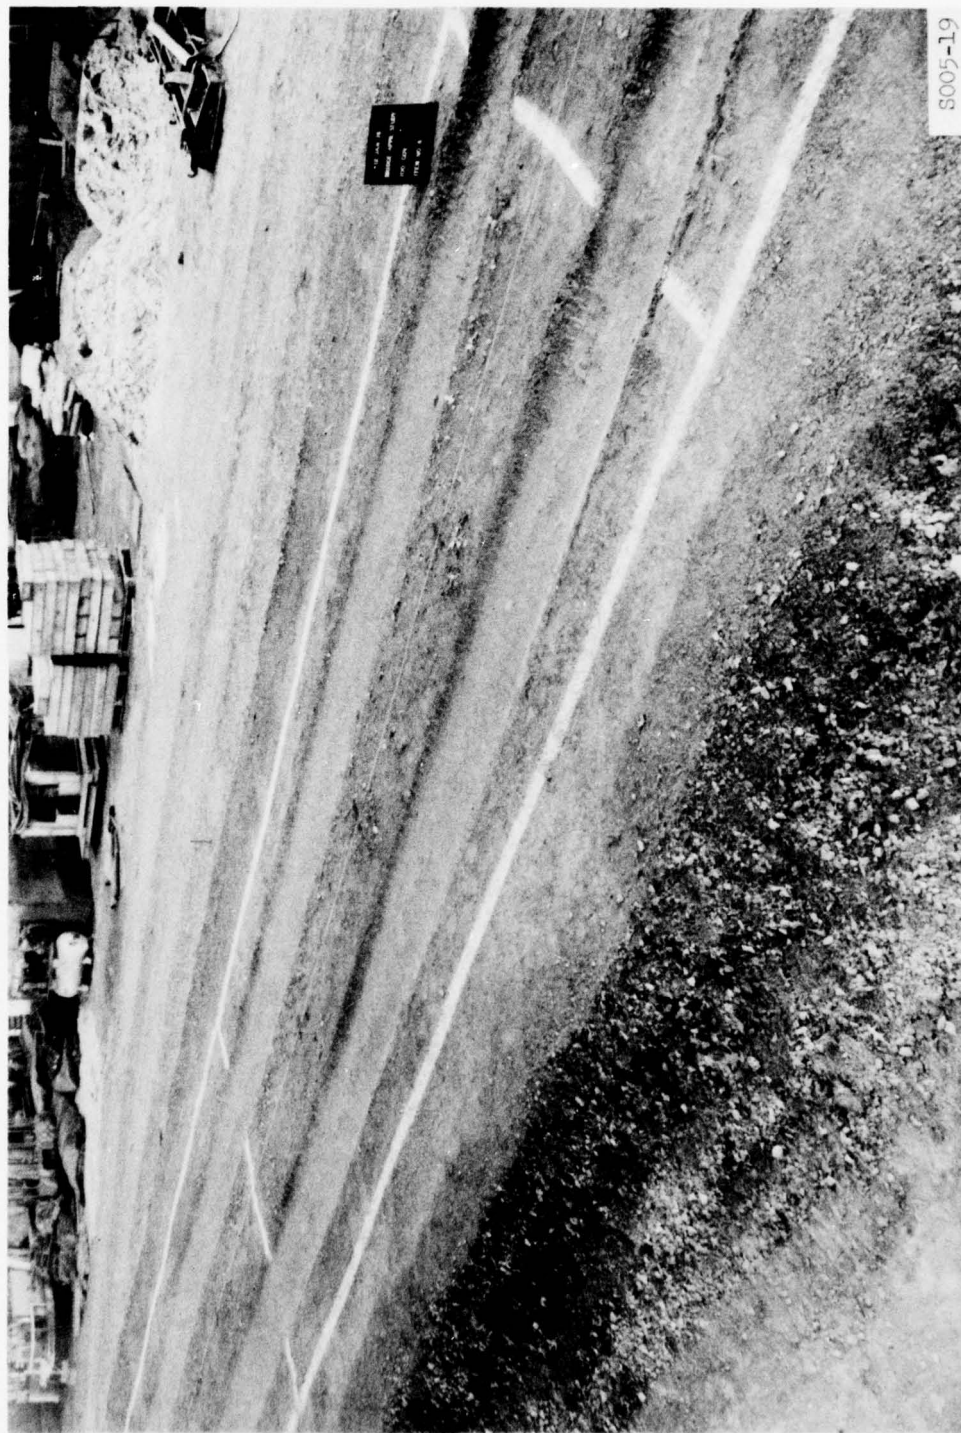
42. Performance of this item was significantly better than that of the control item. After 100 coverages (Photo 31), the average rut depth was 1.8 in. After 200 coverages (Photo 32), the average rut depth was only 2.6 in. Photo 32 shows some transitional rutting resulting from failure of the control item and also some spot rutting at two locations. A test hole was dug into the larger spot rut to see if the polyester fabric had been damaged. The fabric was found to be in good condition but did show some signs of stretching.

Photo 31. Item 6 after 1000 coverages

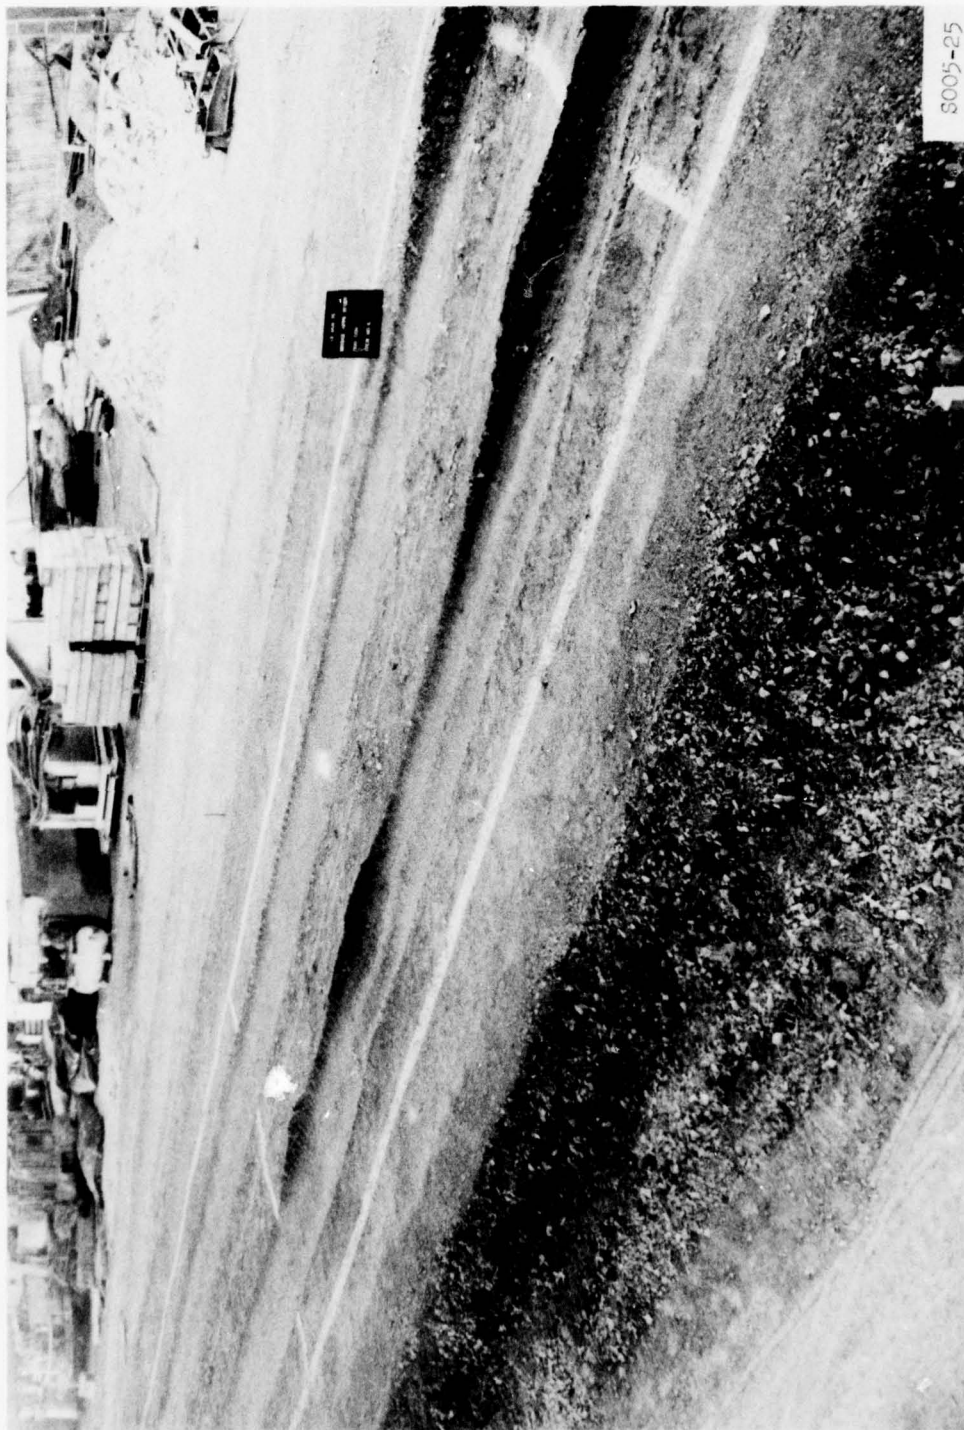
Photo 32. Item 6 after 200 coverages

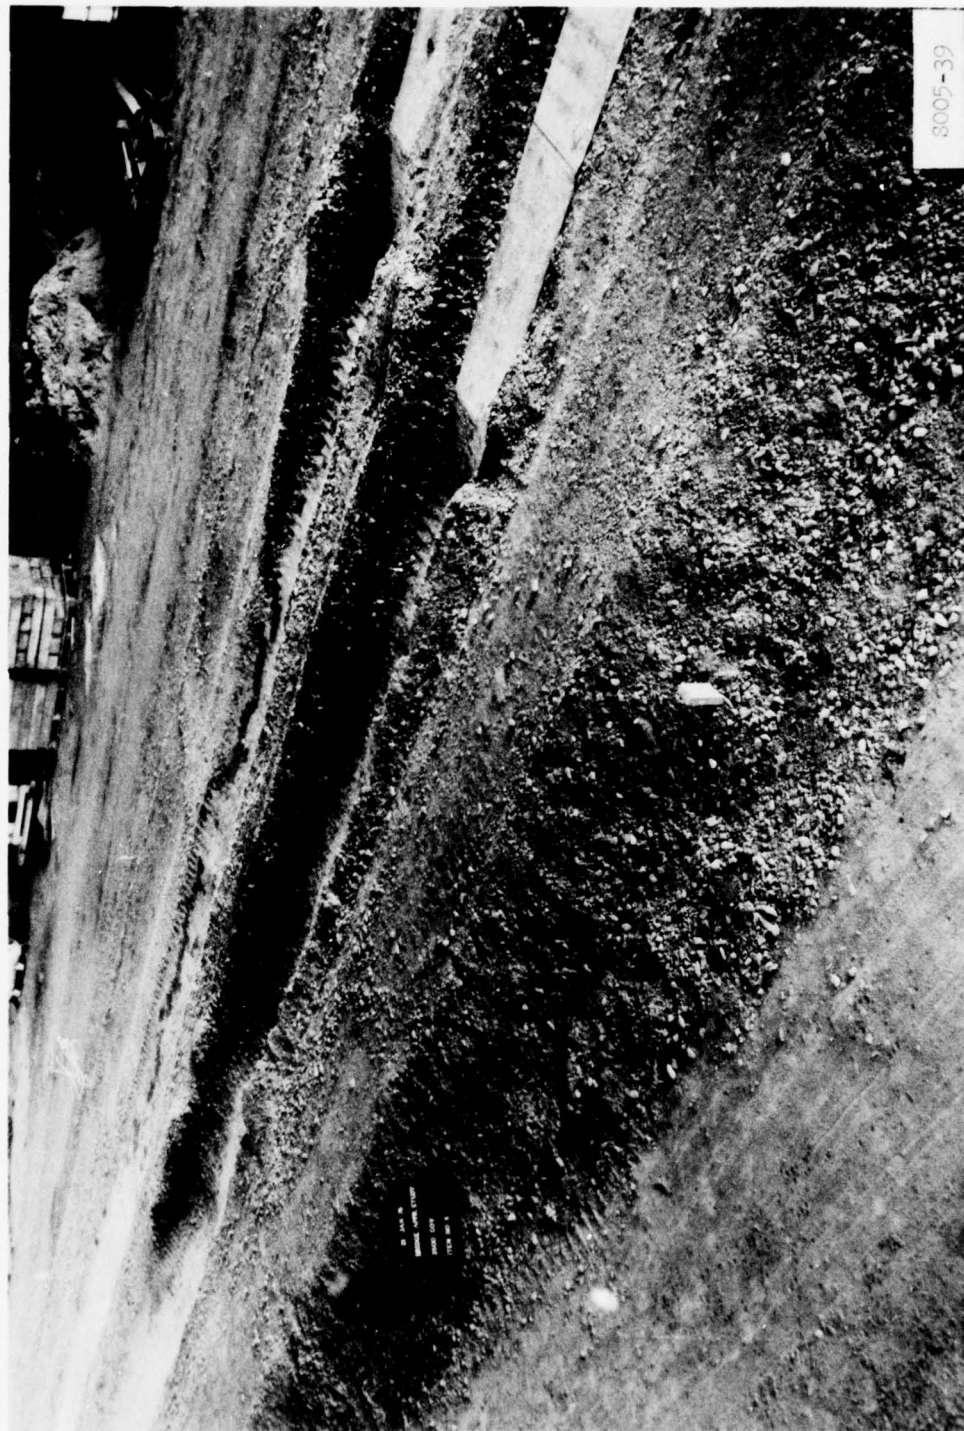
30. Normal tracking procedure was to allow test traffic to continue on an item until an 11-in. rut developed, at which point the differential on the truck would drag. The item would be considered failed at this time, and test data would be taken. The ruts in a failed item were lined with a runner of landing mat (Photo 33) to allow traffic to continue on unfailed items.

Photo 33. Item 6 after 2500 coverages

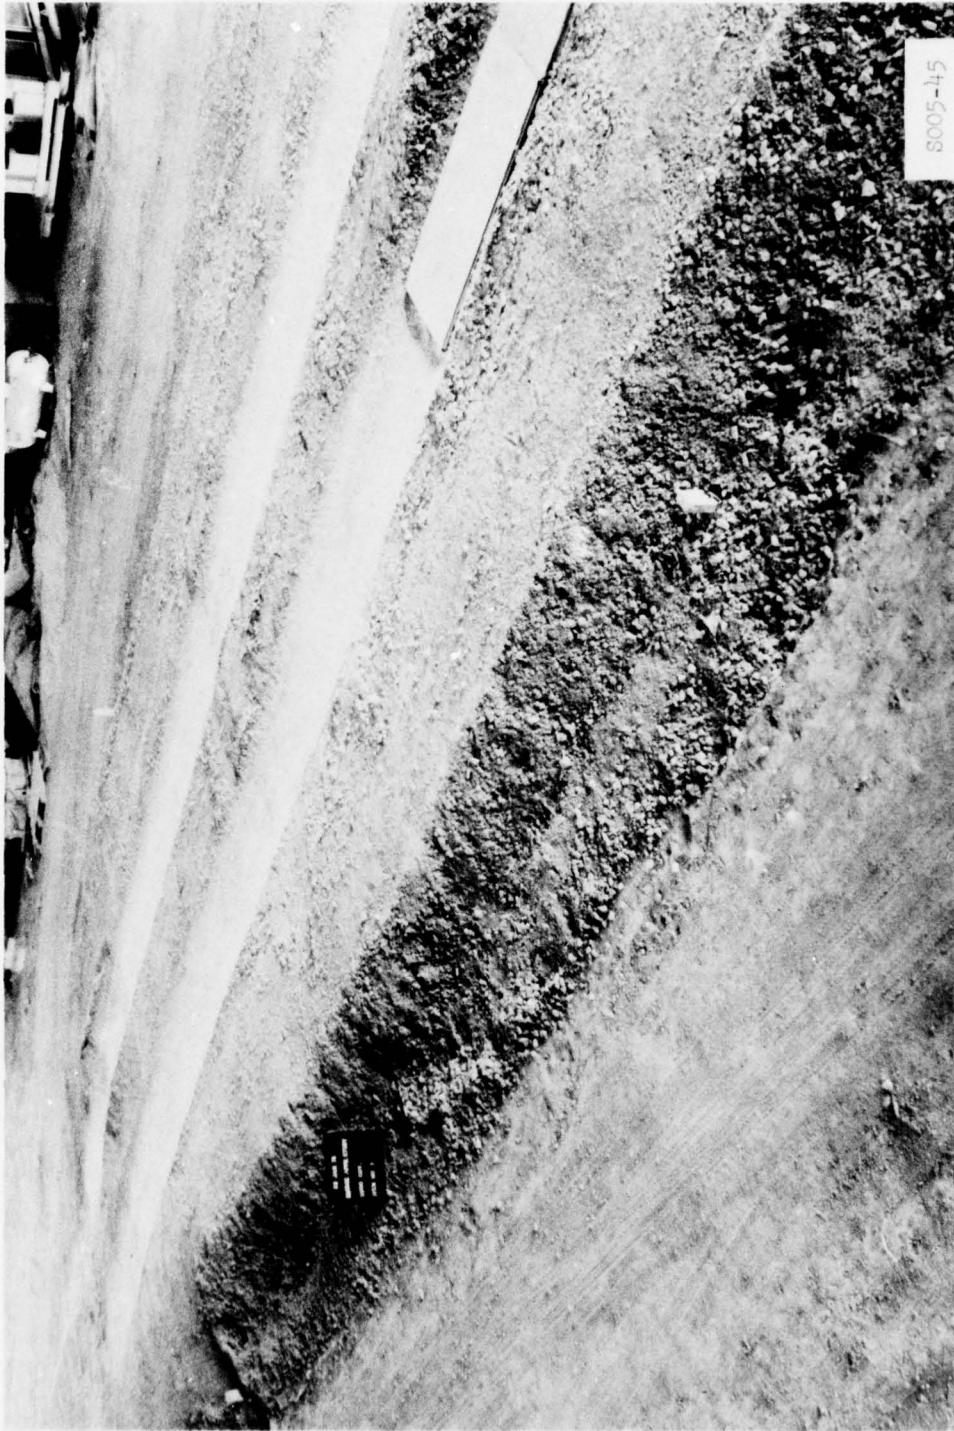
45. Performance of this item was outstanding. Photo 34 shows this item after 5500 coverages. Average rut depth was only 1.8 in. An 11-in. rut did not develop until 37,000 coverages. Traffic on this item was continued to 54,000 coverages (Photo 35) to see if the T-16 membrane would tear. However, after 54,000 coverages, the membrane was still in good condition. Plate 9 shows cross-section data for this item. It is interesting to note that failure was caused by subgrade rutting and was not accompanied by base flow from under the wheel paths.

Photo 34. Item 7 after 5500 coverages

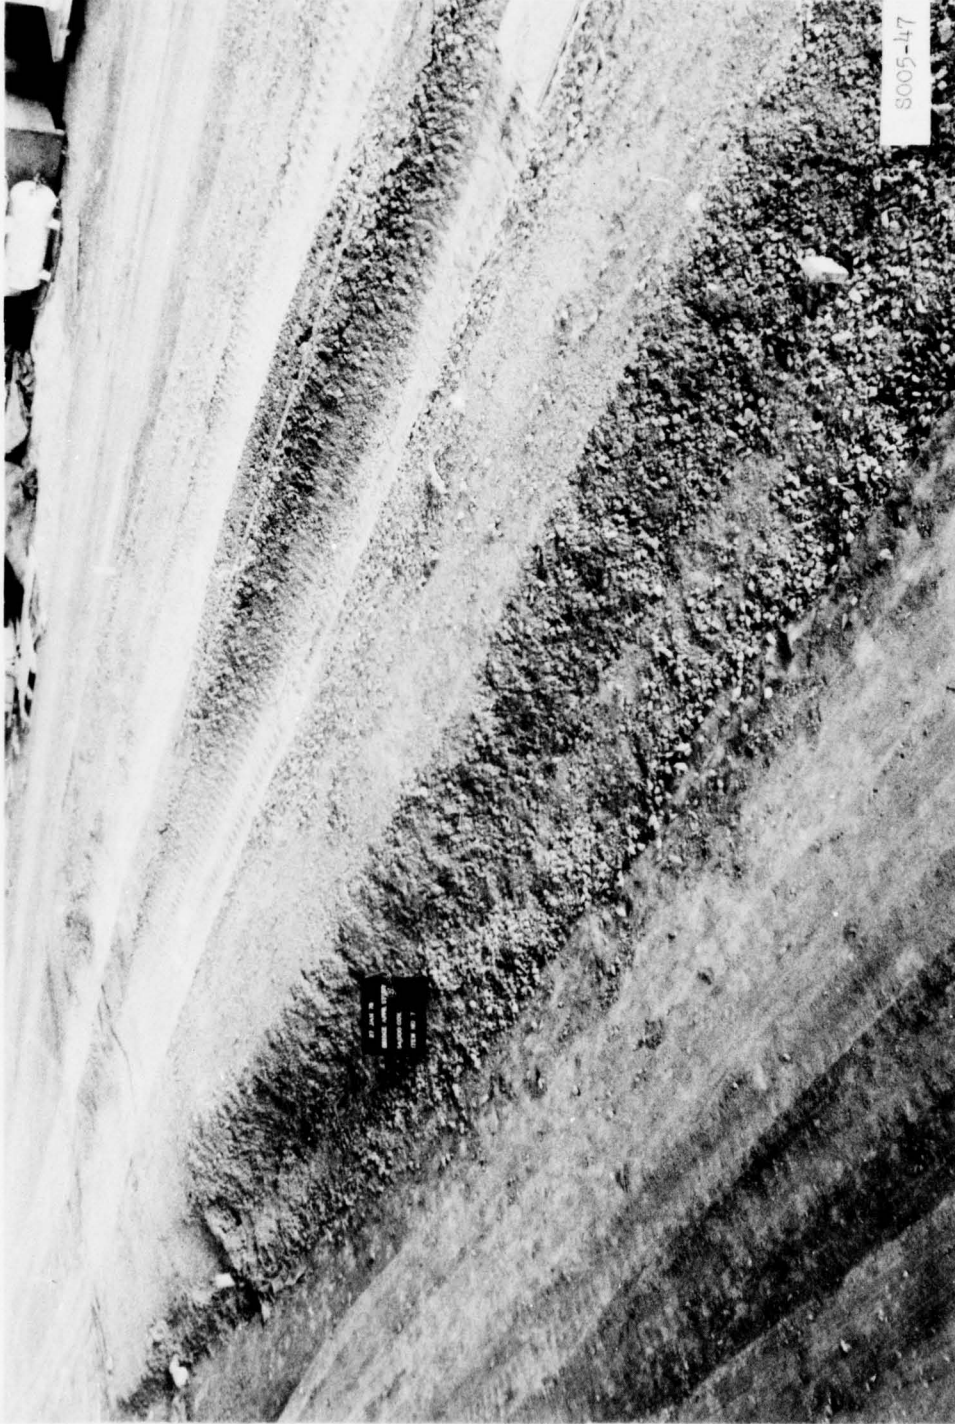
Photo 35. Item 7 after 54,000 coverages
